Cranberry Dam Rebuild

Tone/WCT • November 2020
- October 2021

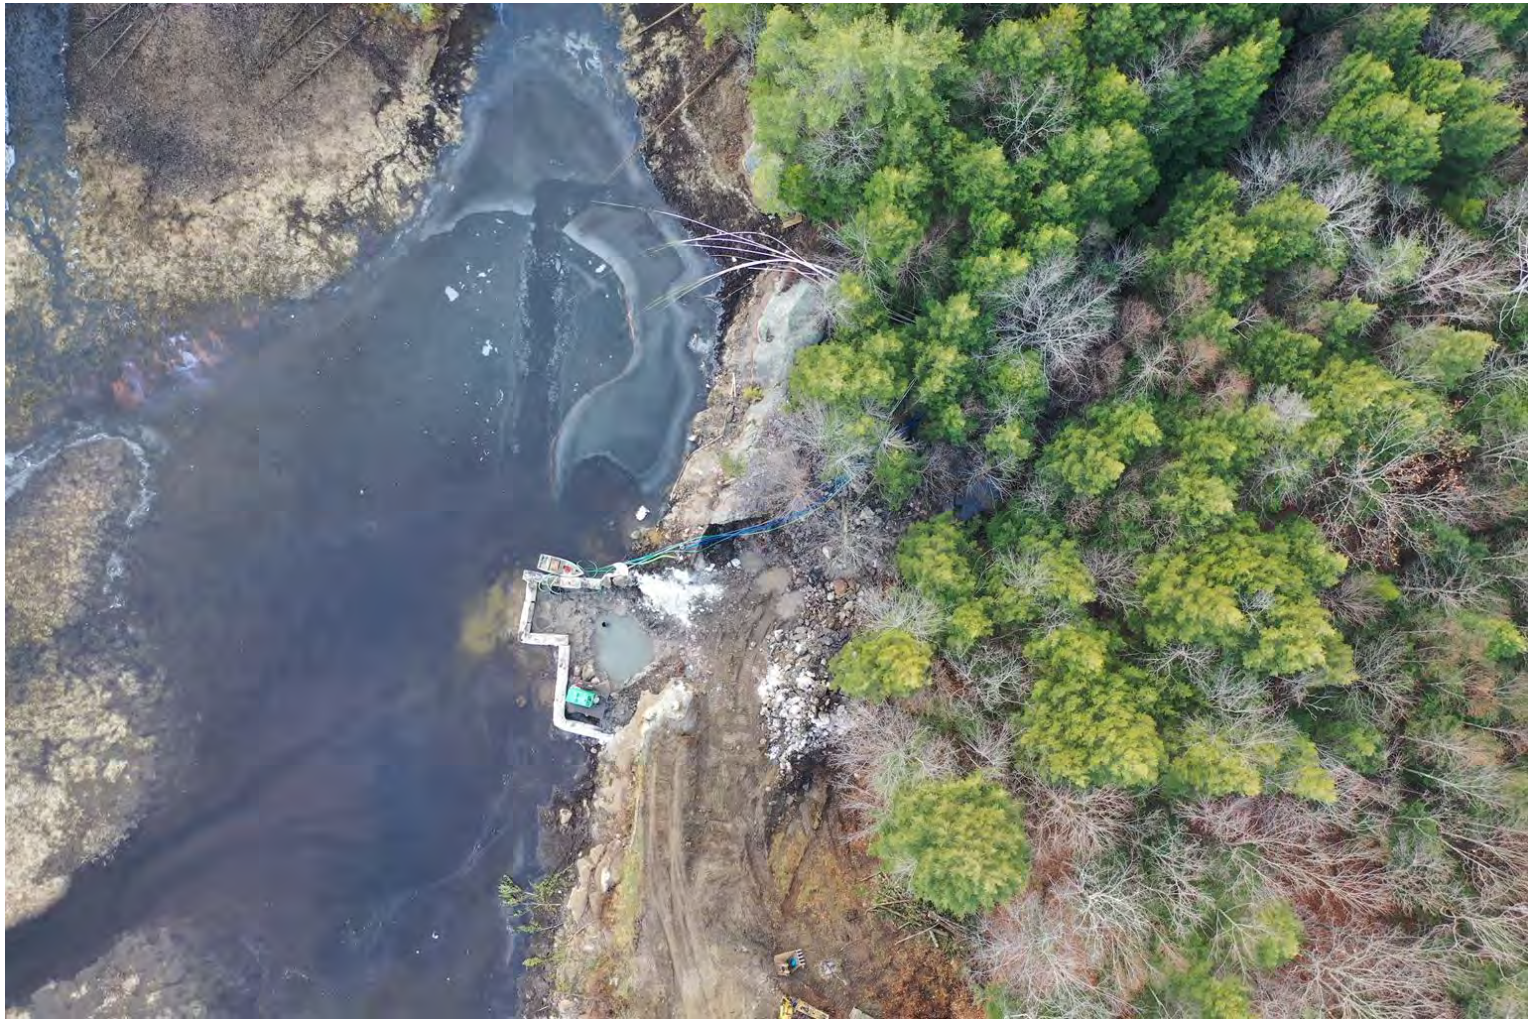
Material Processing

An aerial photograph of a construction site in winter. The ground is covered in snow, with exposed brown earth and concrete structures. A network of yellow, green, and blue rebar is visible, extending across the site. A small white boat is parked on a dark, possibly paved or wet, area. A white vent cover is visible on a concrete wall. The overall scene depicts a complex construction project during the winter months.

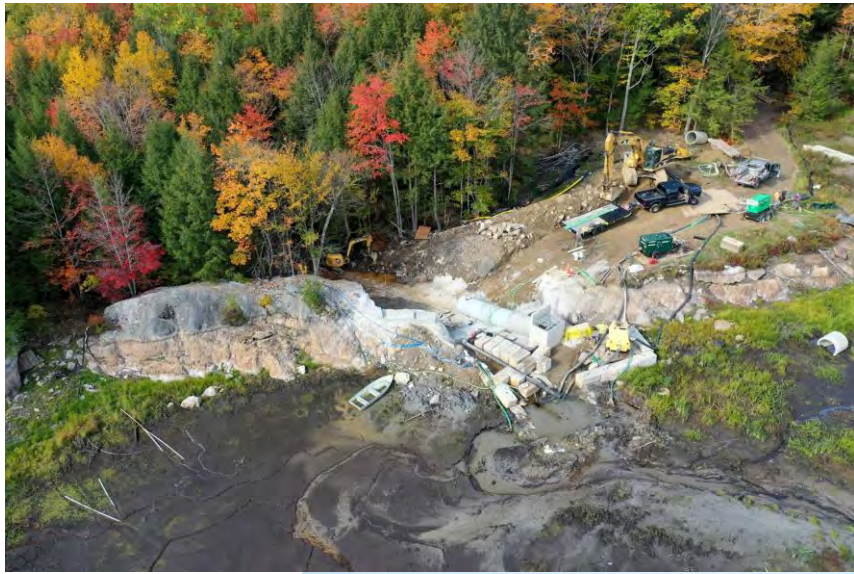
Photo 2: Cutoff wall reinforcement. Note cutoff wall will be at mid-span of RCP.

- The alignment of the concrete cutoff wall was noted to be at mid-span of the 48-inch RCP pipe. No pipe joints will be embedded within the wall. See Photos 2 and 3.
